**Federal Aviation Administration
Supplemental Report to OSC**

File DI-10-2602

**Director, Audit and Evaluation (AAE-1)
Federal Aviation Administration**

May 18, 2011

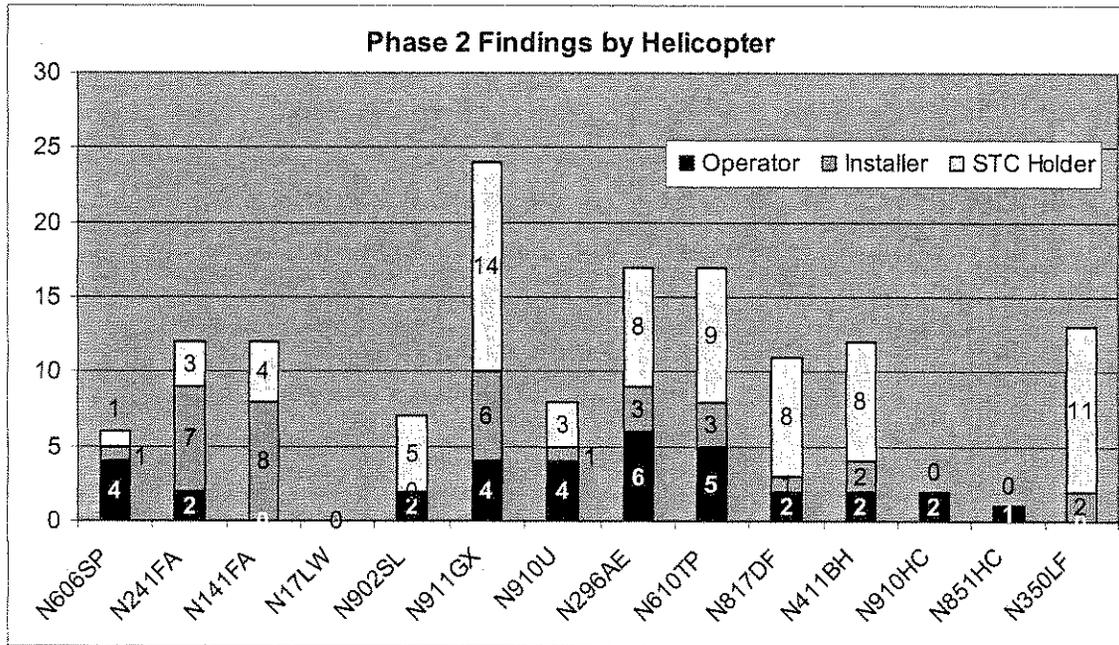
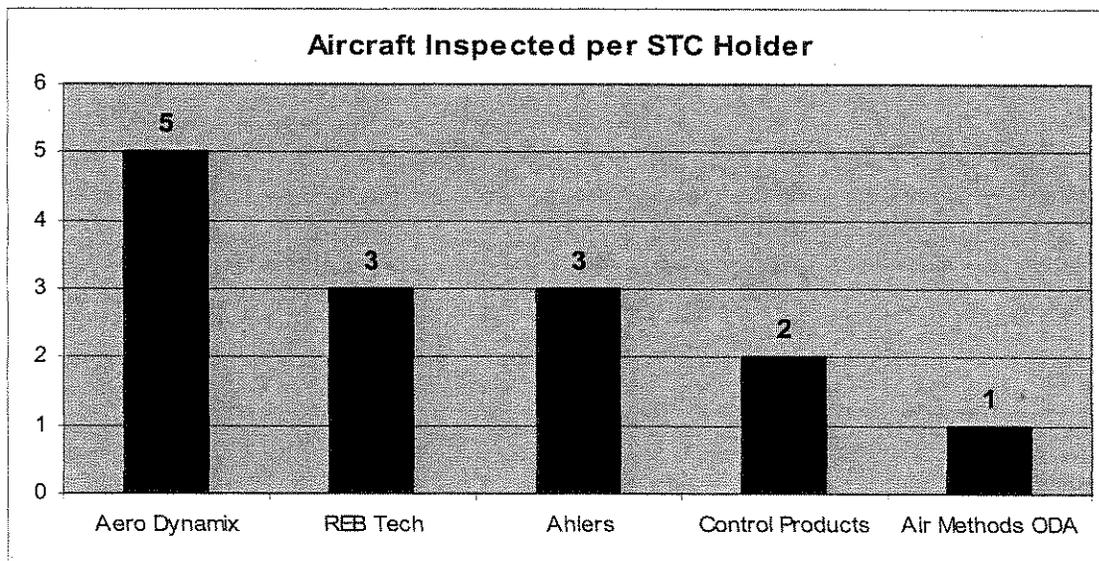
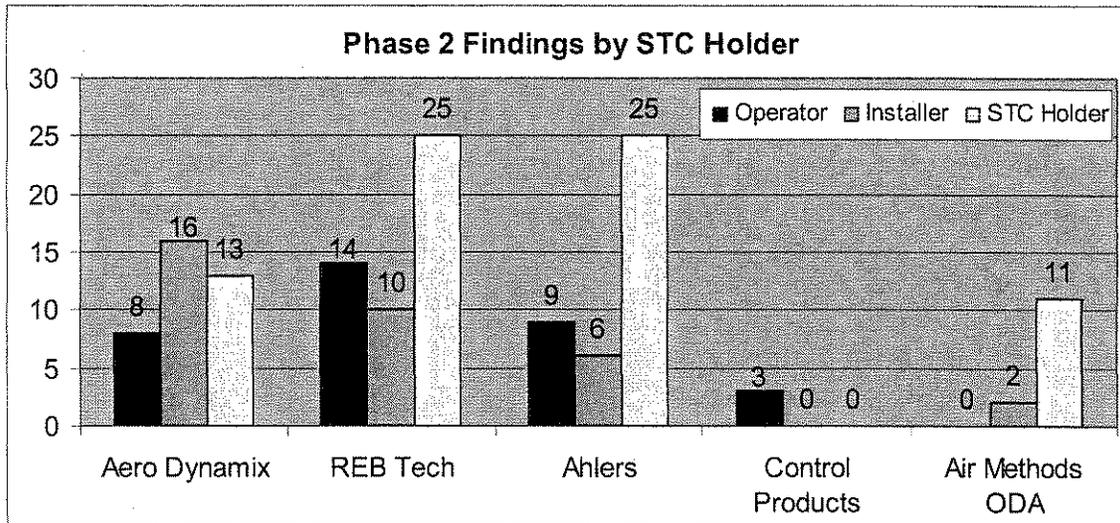
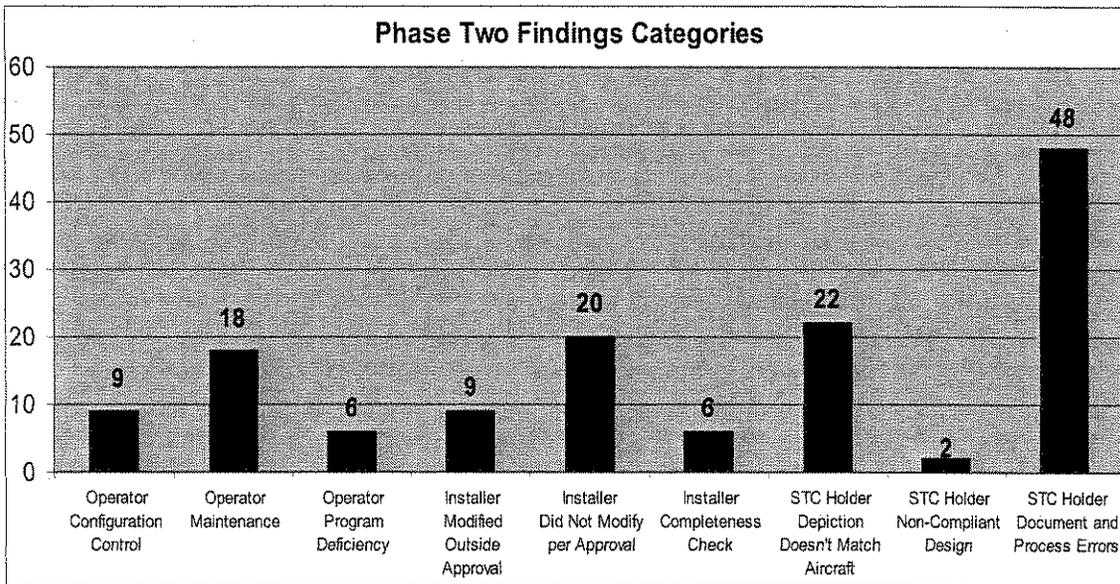
Phase 2 Audit Findings

The following bar charts indicate the Phase 2 Audit findings associated with the audit. The charts indicate there was a total of 14 helicopters inspected resulting in 142 findings. The final two bar charts indicate Phase 2 vs. Phase 1 by finding category.
